NASA CR-66840

METEOROID PENETRATION DETECTOR DEVELOPMENT PROGRAM

FINAL SUMMARY REPORT  
VOLUME I

Prepared under Contract No. NAS1-7043 by  
MARTIN MARIETTA CORPORATION  
Denver, Colorado

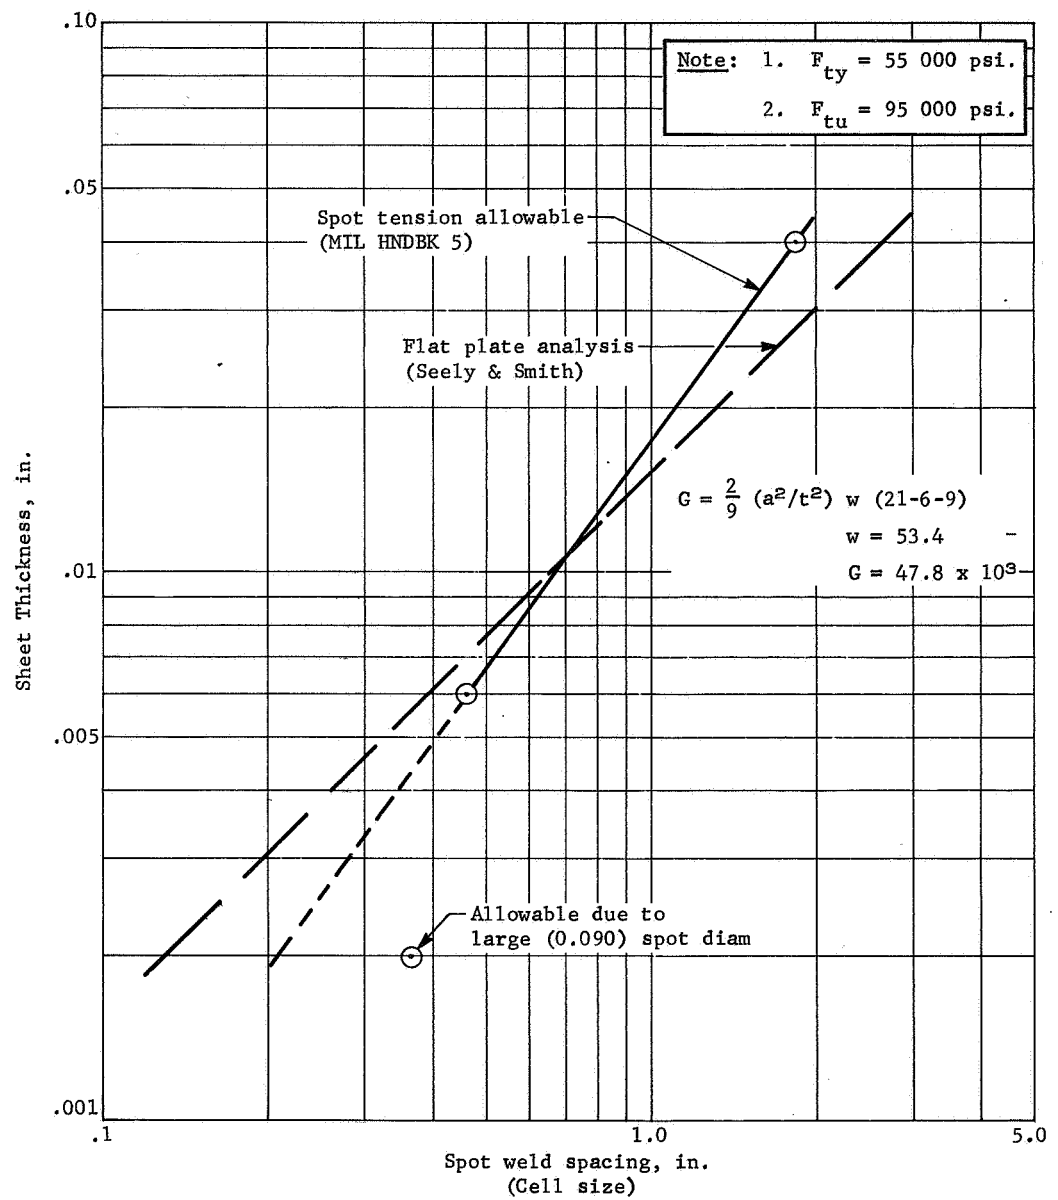
Figure 7.- Spotweld Spacing (Square Pattern), Material 21-6-9 Stainless Annealed

A stress level of 15 000 psi (thusly computed) proved to be a good indicator for test survival for square pattern pressure cells. Other pressure cell shapes were evaluated in a similar manner. Data for spotwelded hexagonal cells is shown in figure 9.

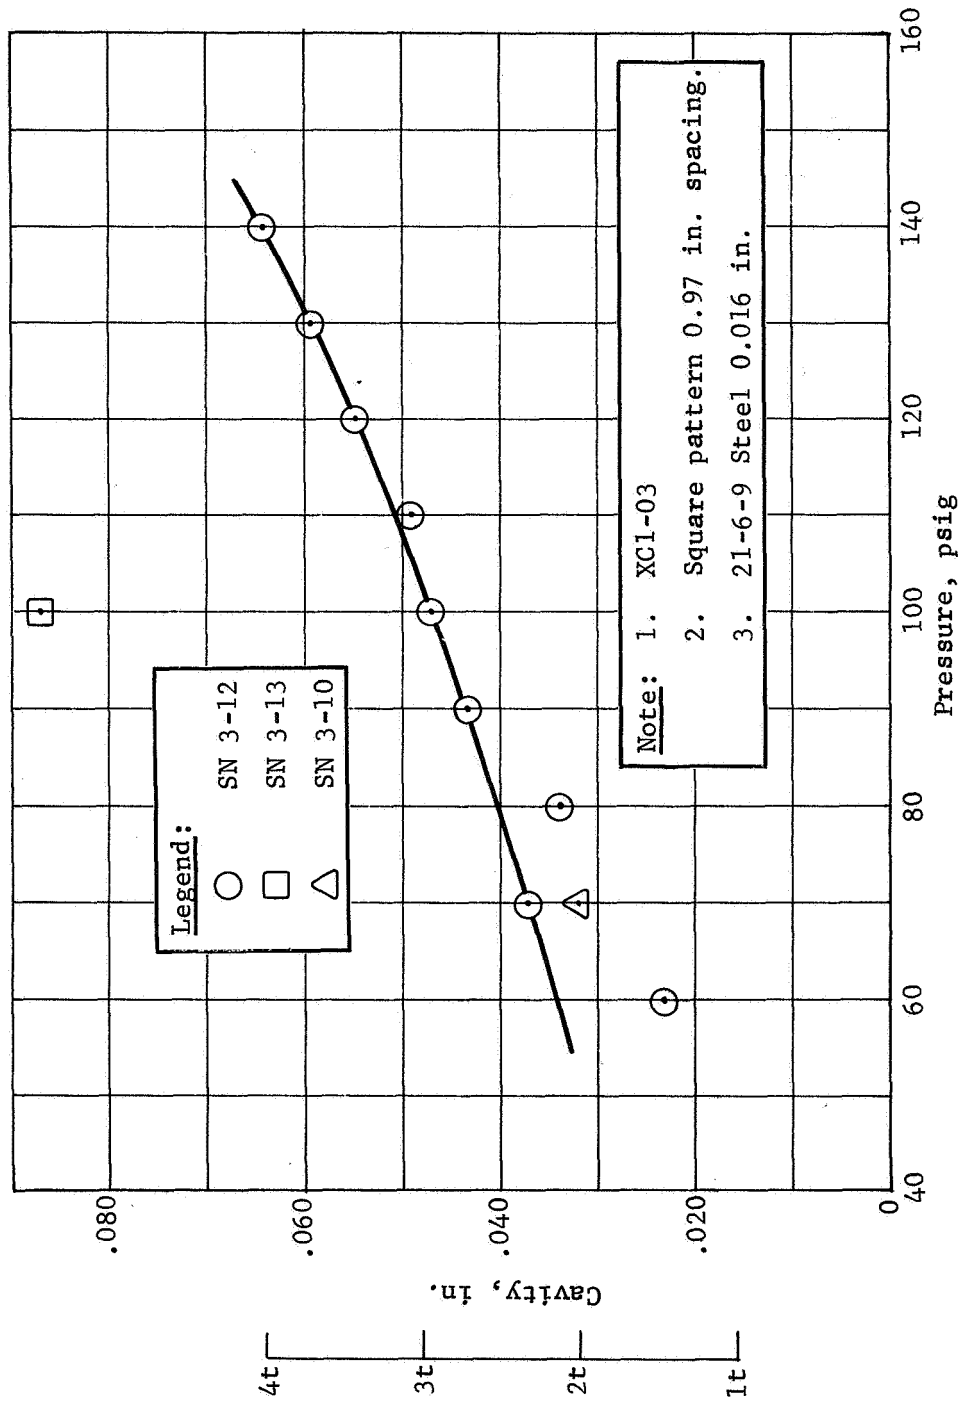
Figure 8.- Detector Pillow Cavity vs Expansion Pressure

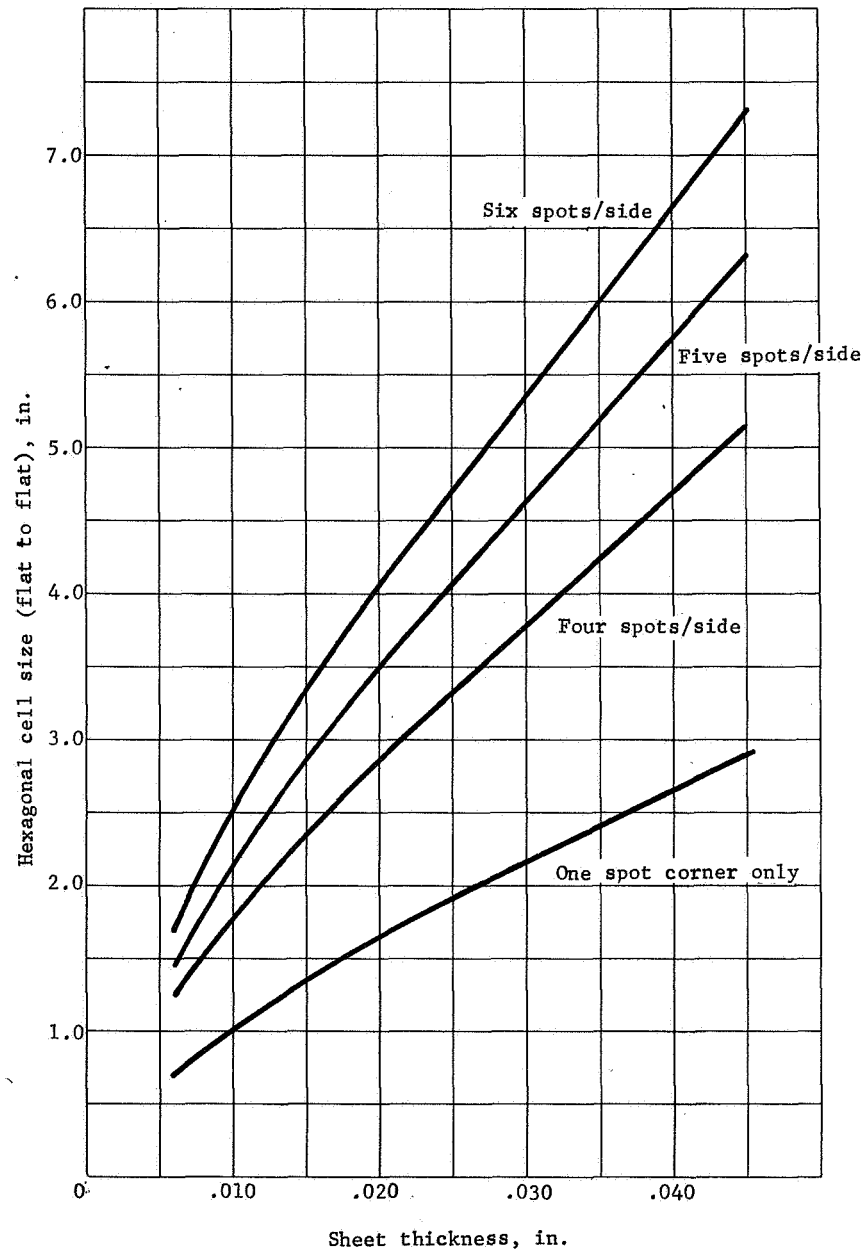
Figure 9.- Spotwelded Hexagonal Cell Size vs Thickness, 21-6-9 Stainless Steel

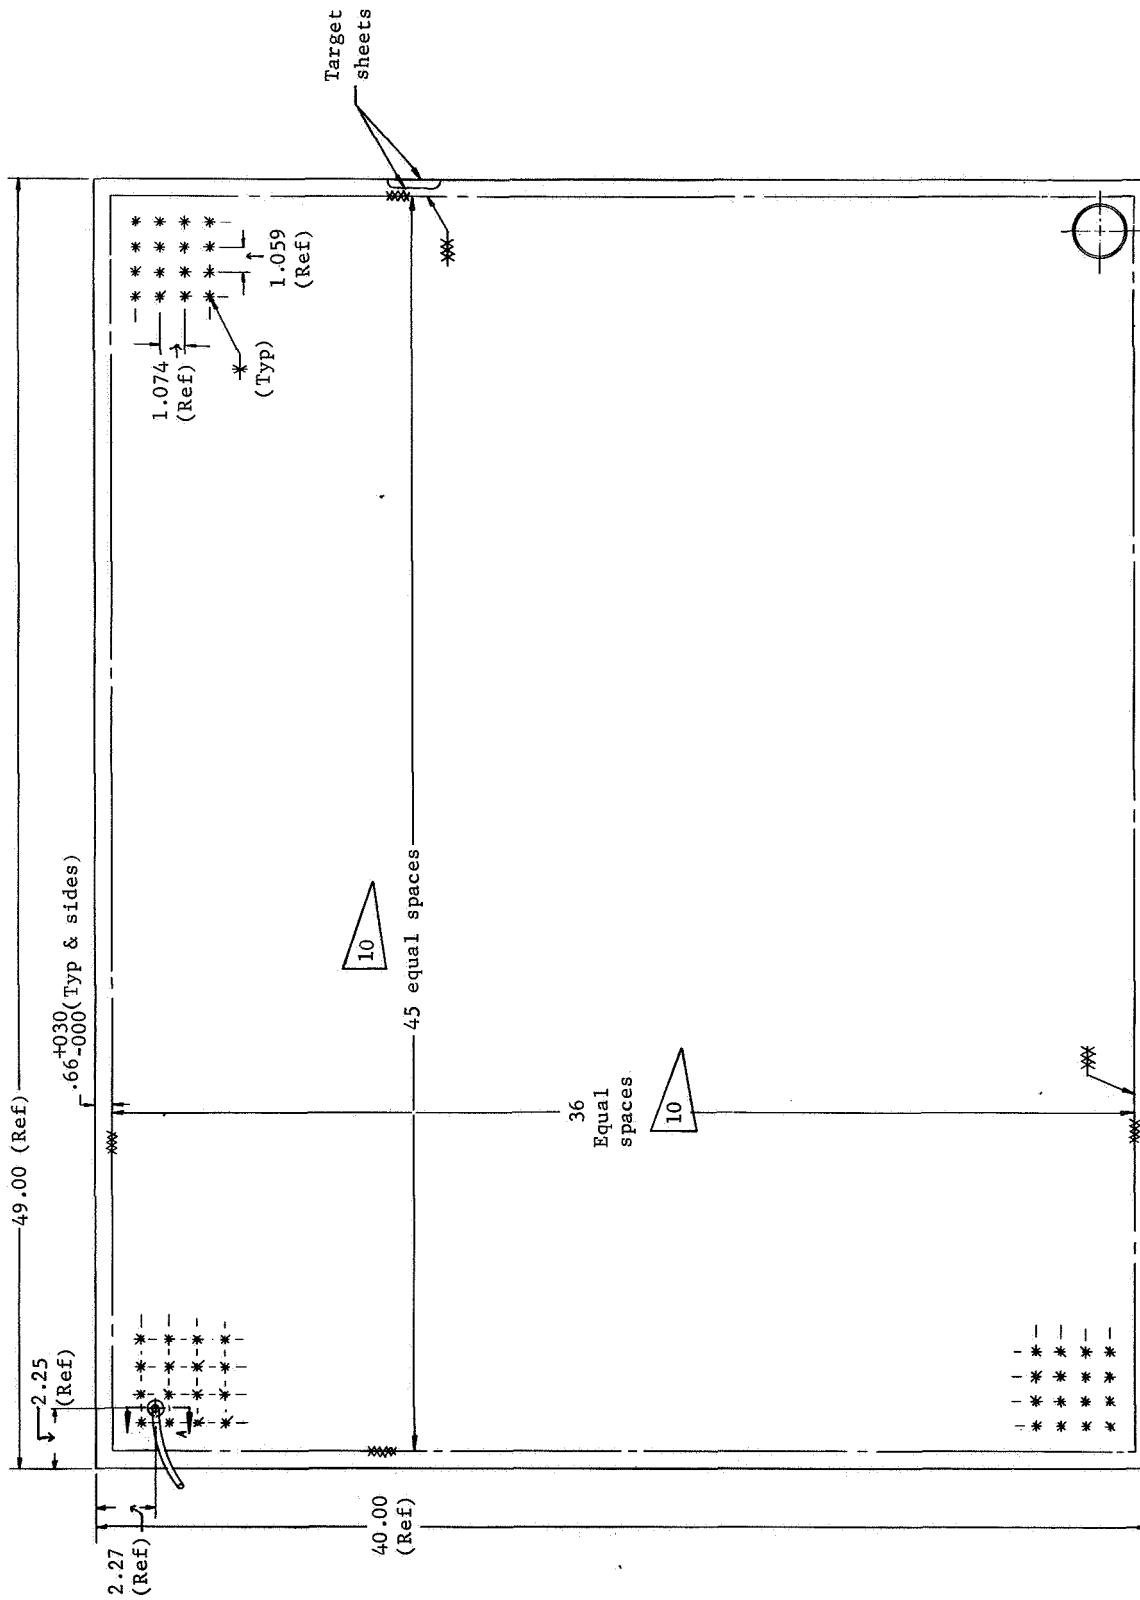
Figure 10.- Detector Assembly, D3A

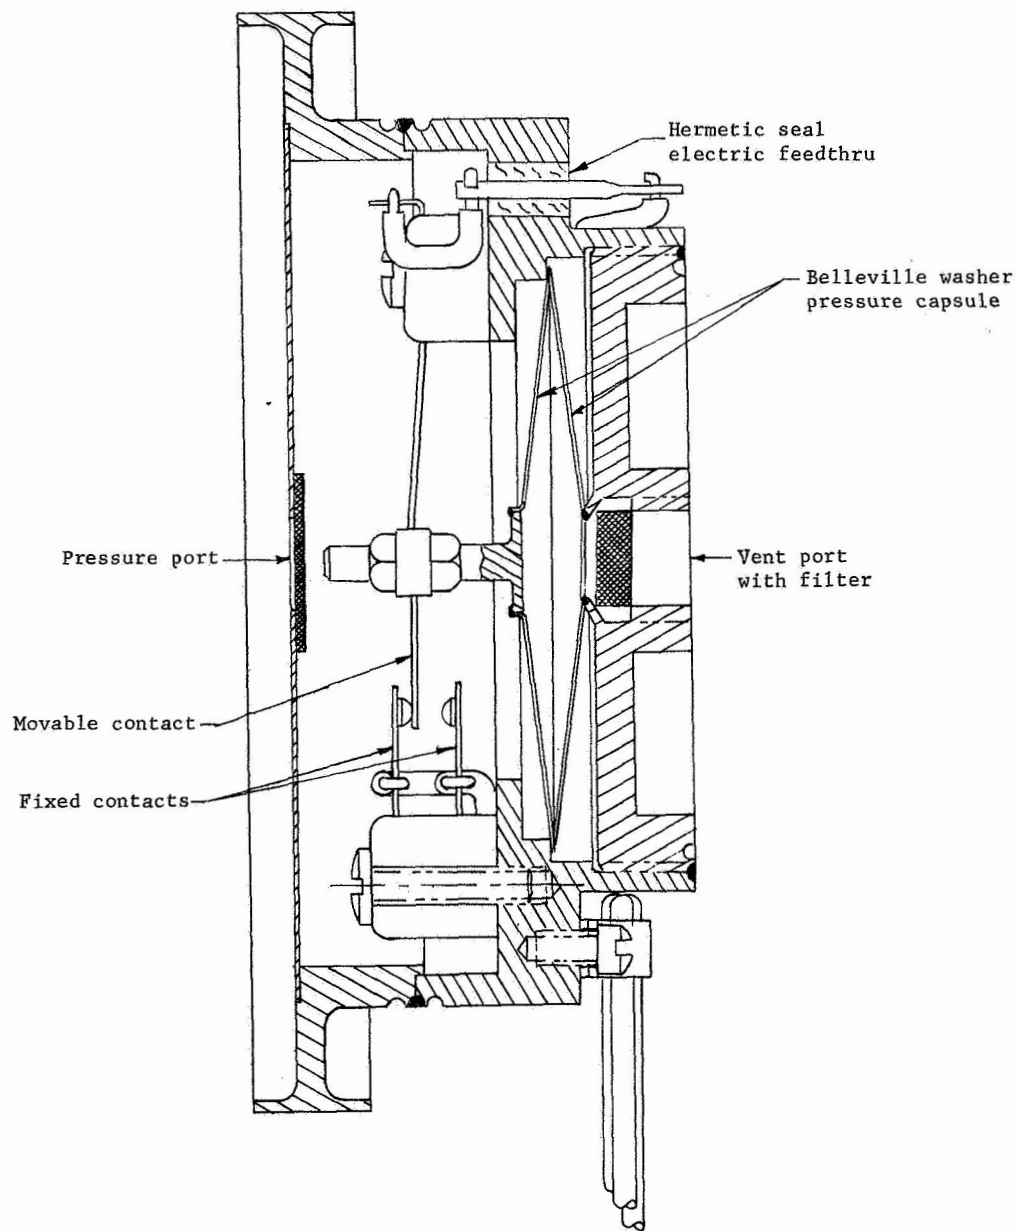
Figure 11.- Servonic Instrument Incorporated Switch Configuration

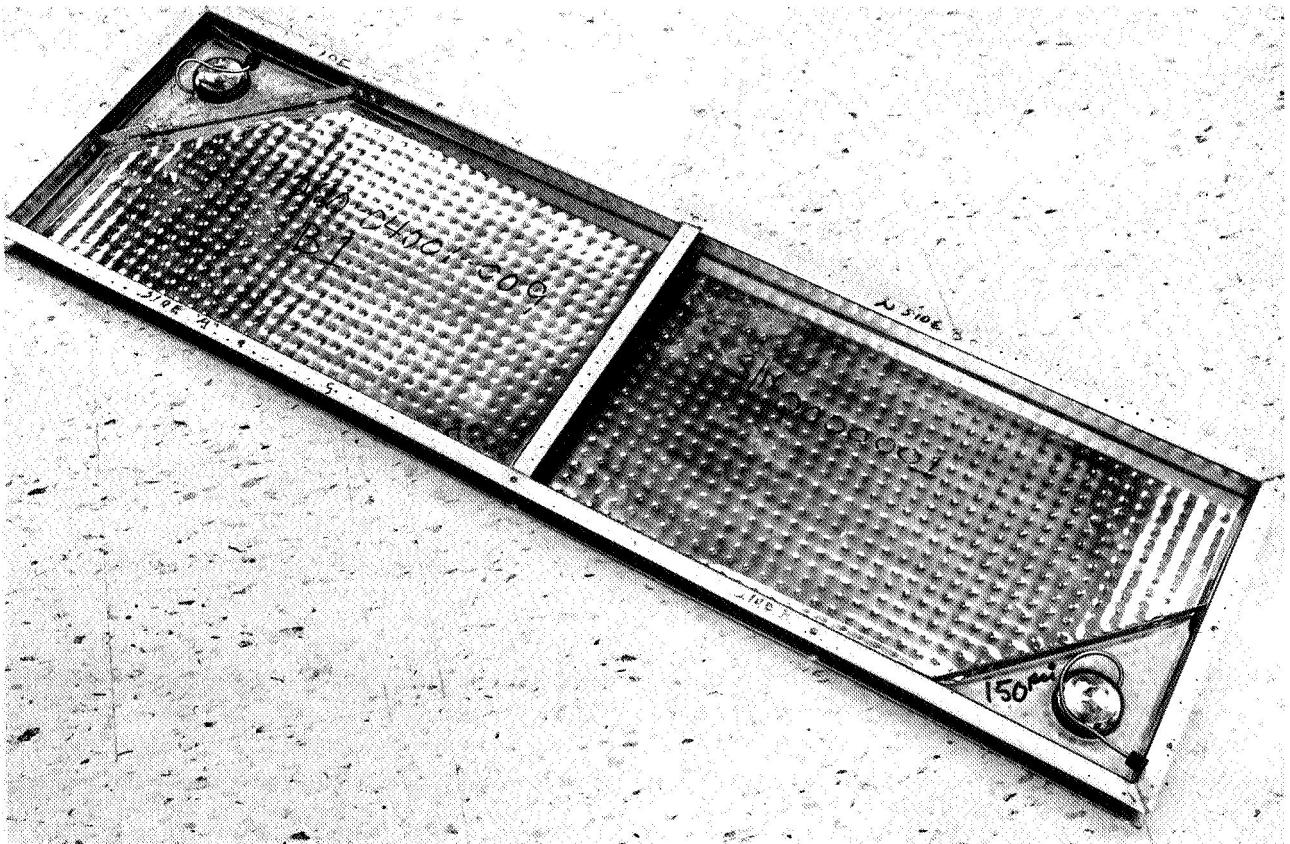
Figure 16.- B1 Full-Size Panel Showing Switch Gusset,  
12x40 in., 21-6-9 Stainless Steel

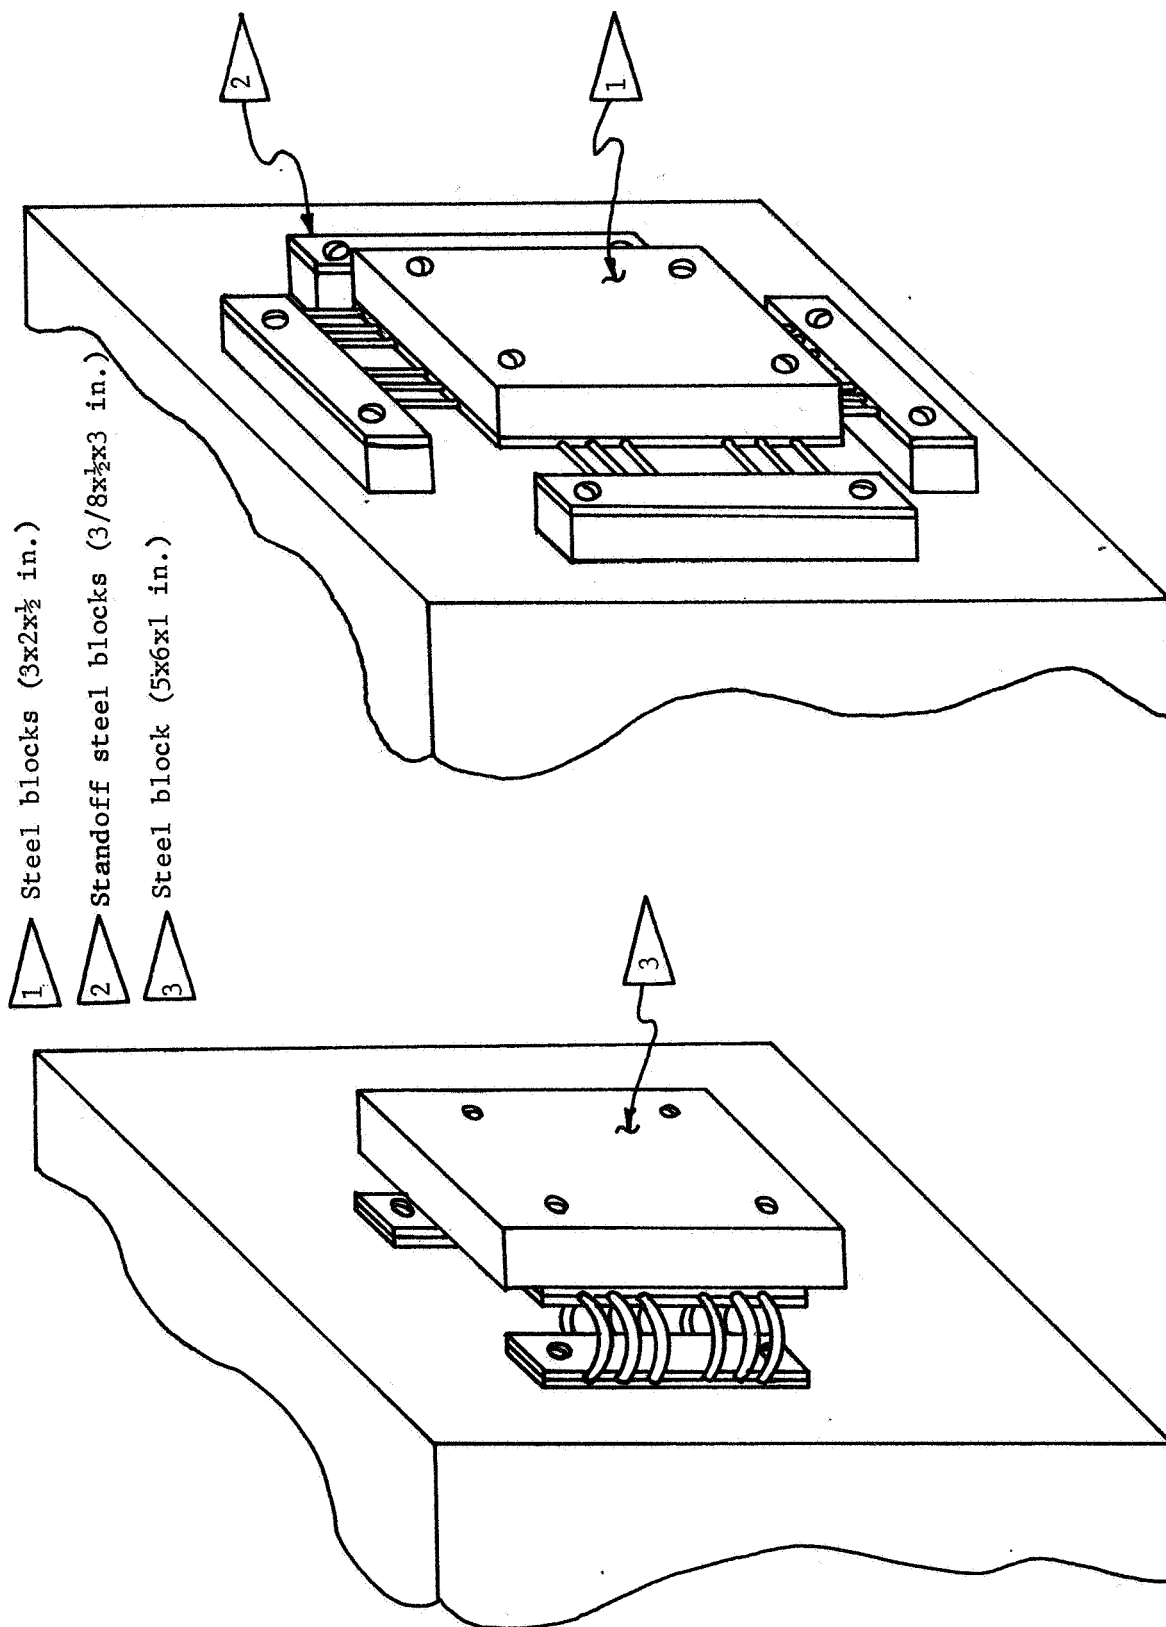
Figure 19.- Commercial Mounts Evaluation

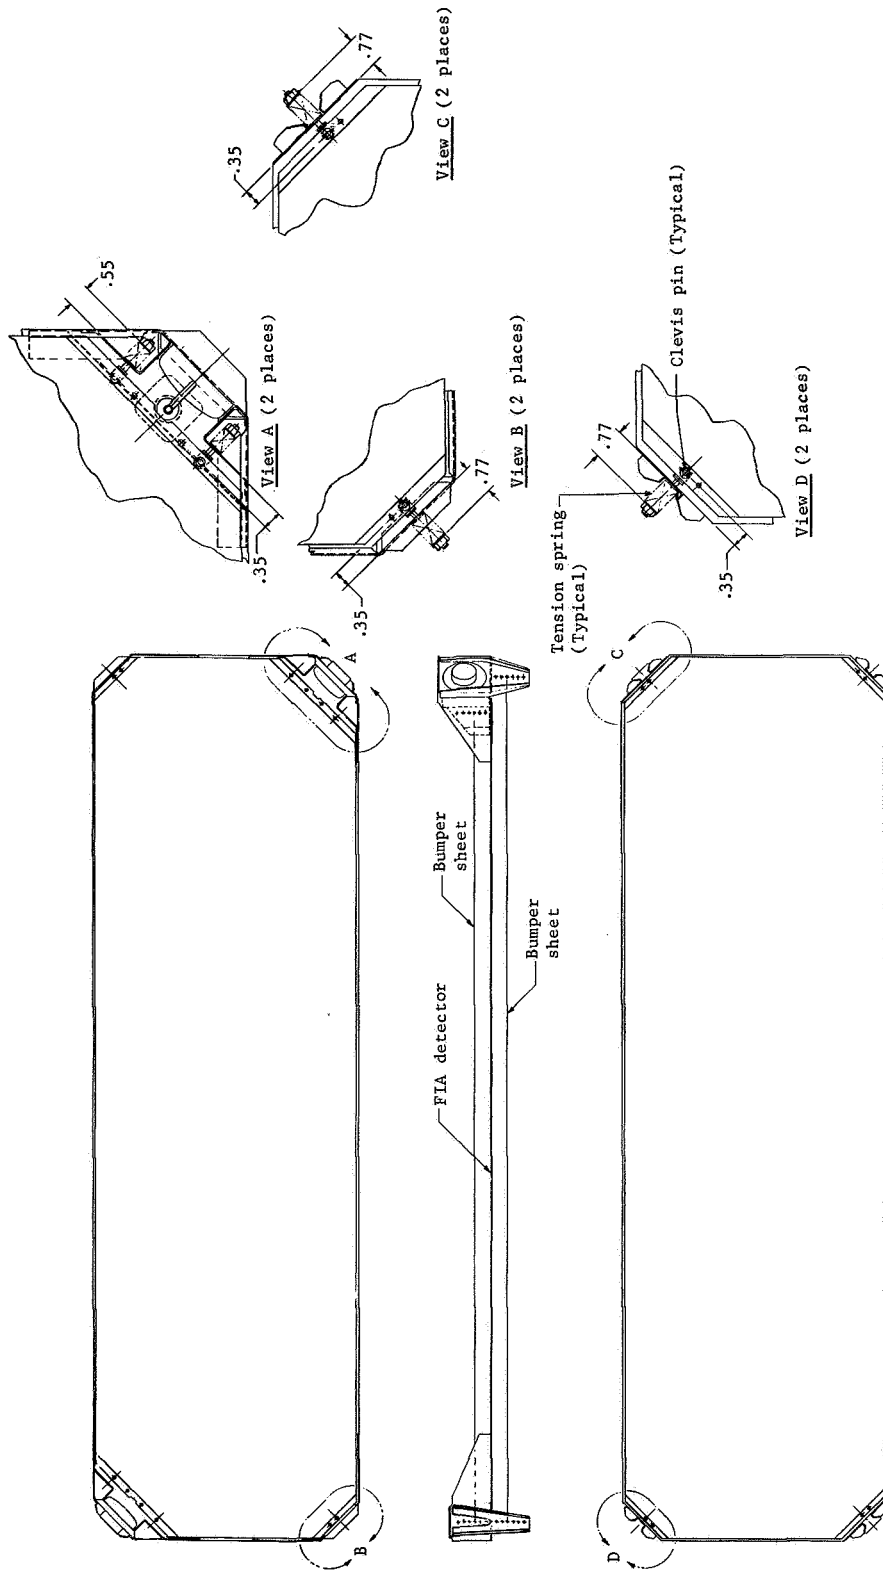
Figure 25.- Bumper Installation FIA

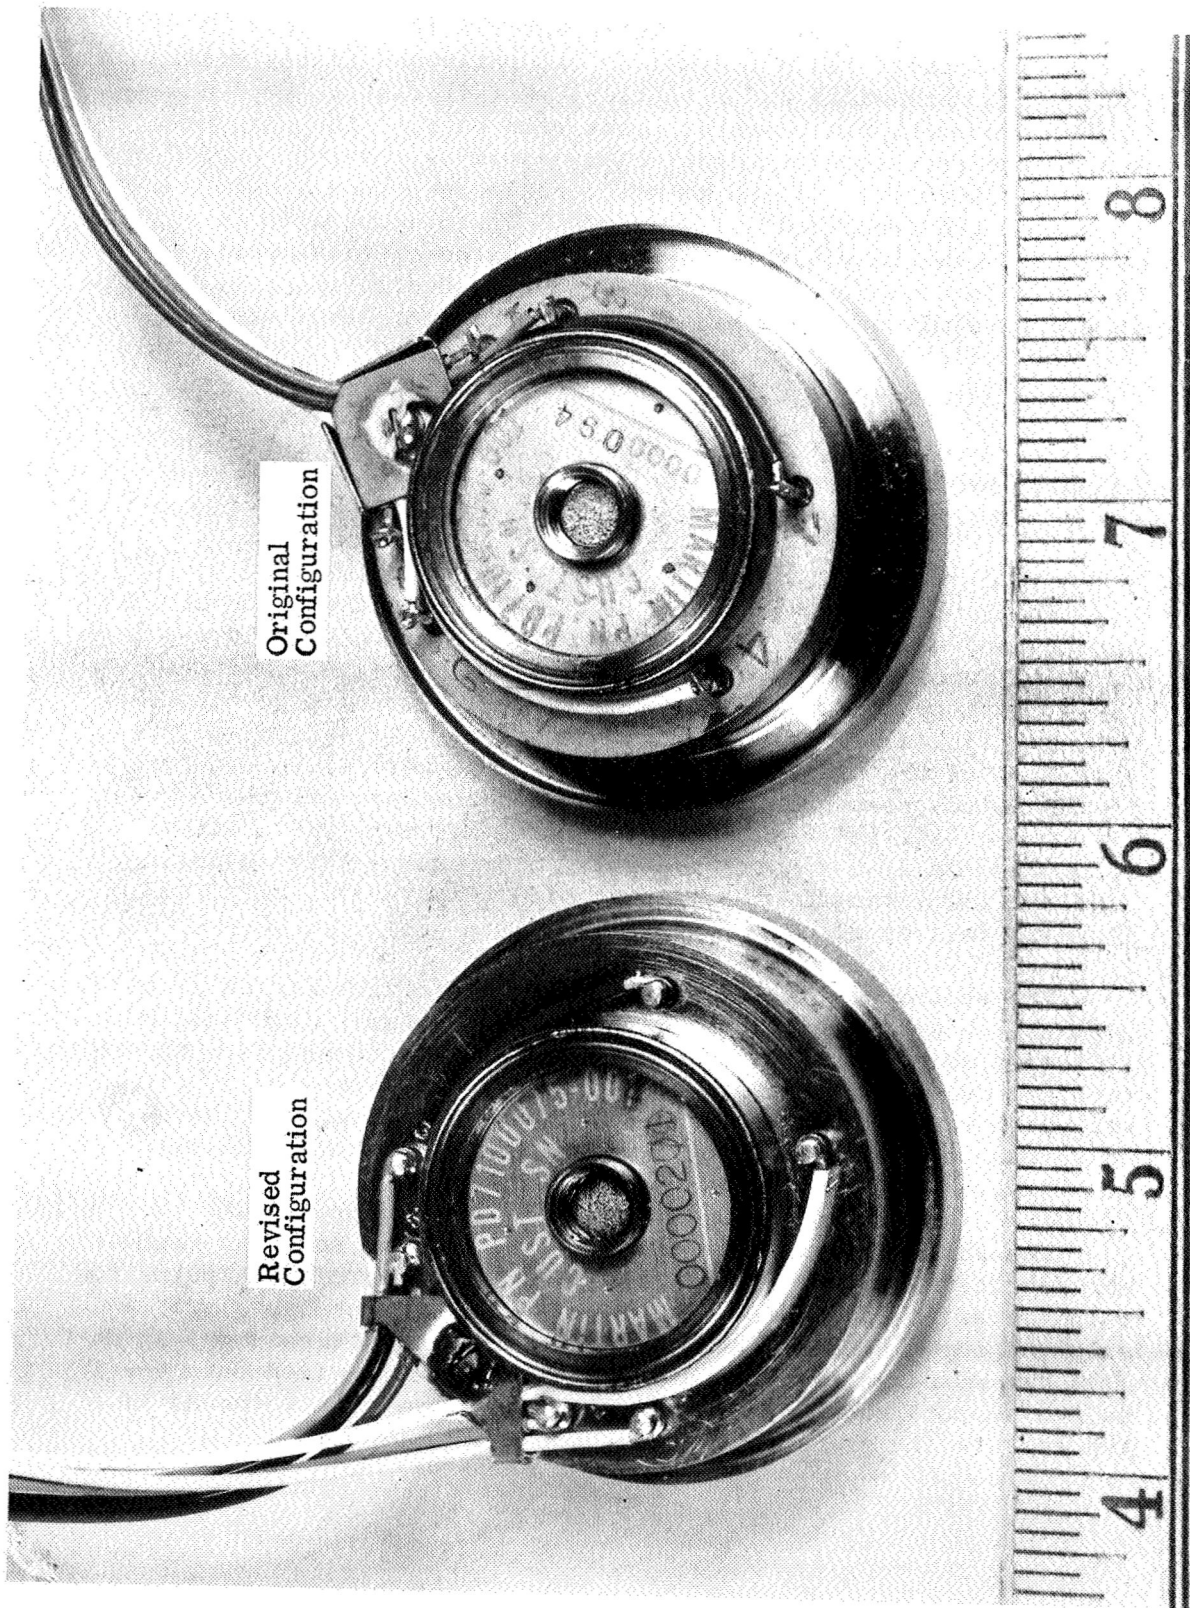
Figure 37.- Servonic Switches

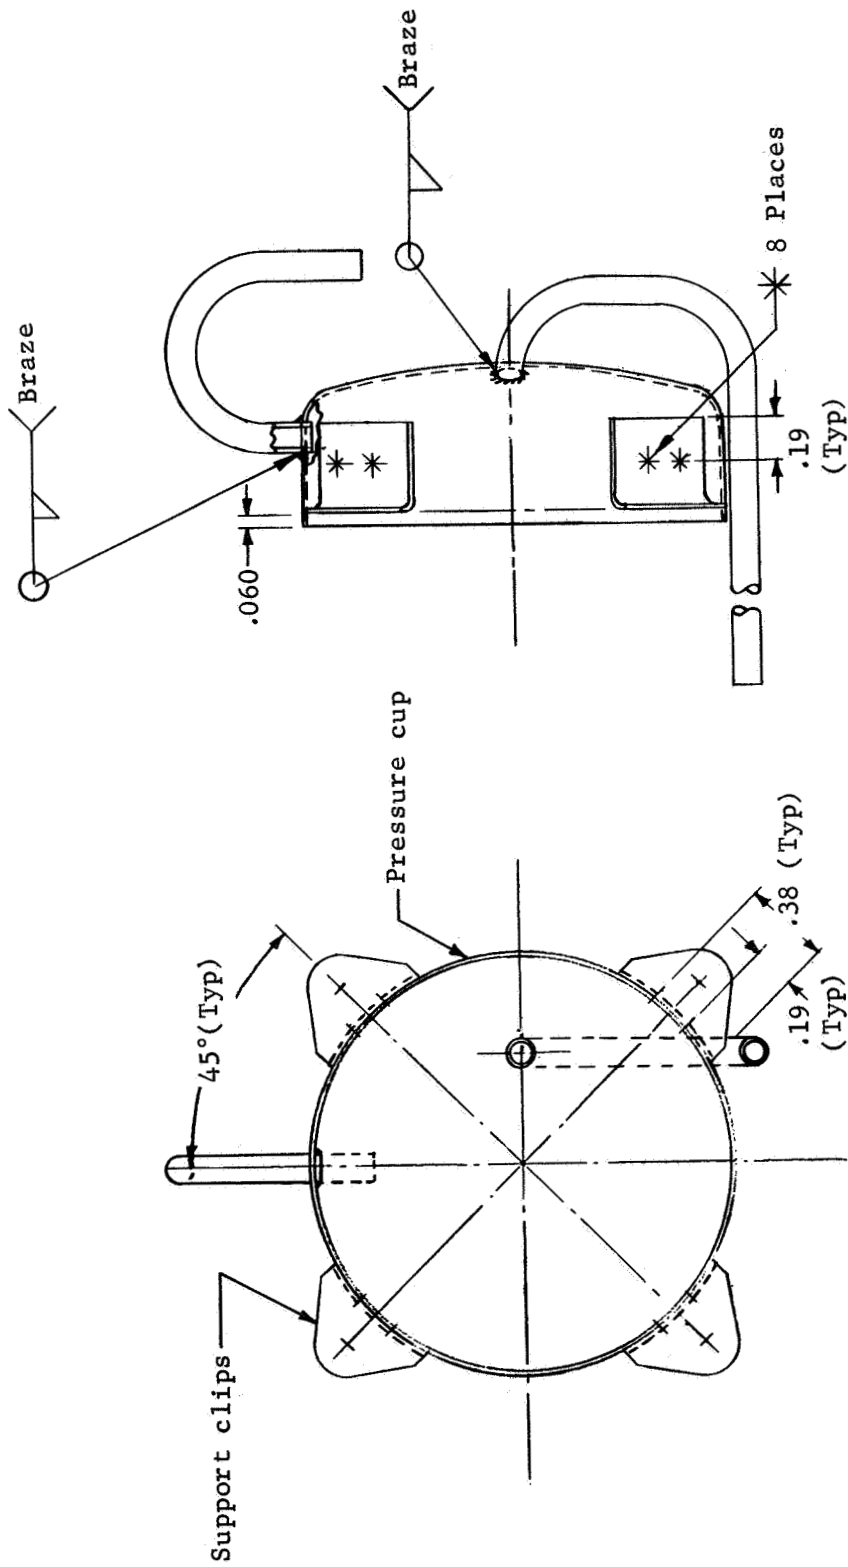
Figure 38.- Switch Cup Assembly

The final design removed the clips from the mounting bracket and fabricated them as separate parts. These were then spotwelded onto the switch pressure cup before welding the pressure switch into the cup. Finally, the cup with the clips attached was slid into the mounting bracket and the clip ears spotwelded onto the switch support bracket. The final design showing attachment of the ears to the pressure cup is shown in figure 38.

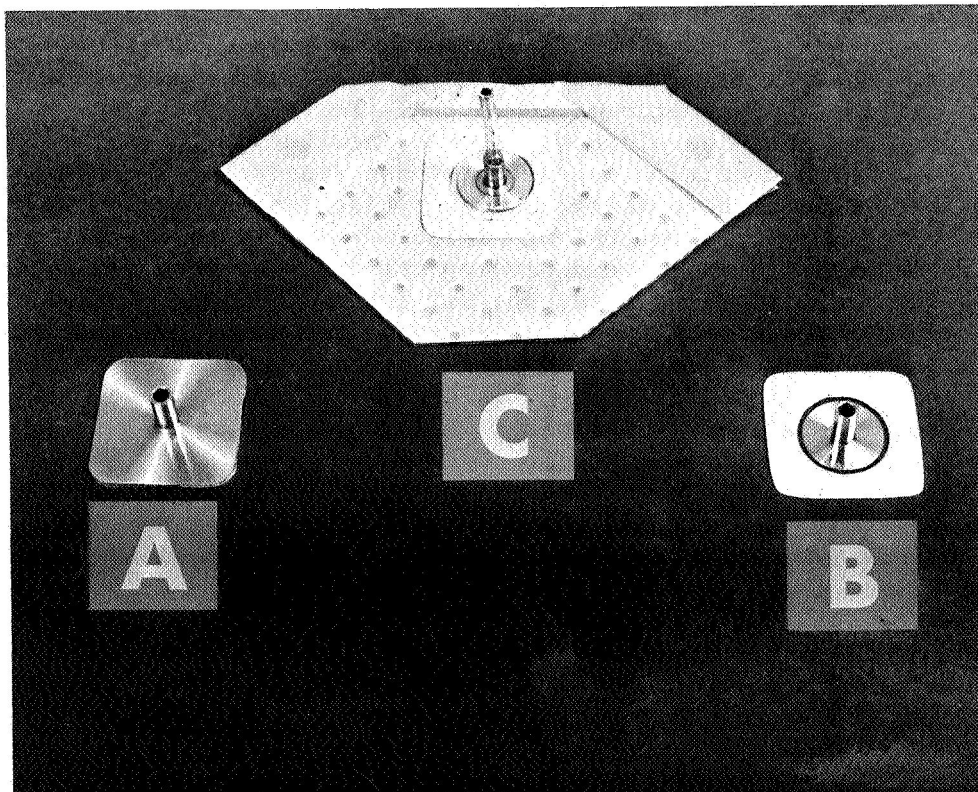
Figure 42.- Panel Fitting Modification

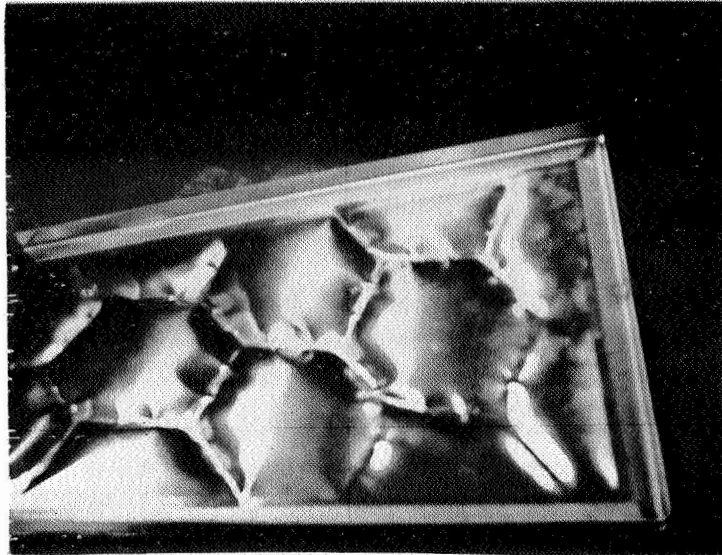
Figure 53.- Pressure Loading Warpage

- Instability of the specimens in the transverse direction of the cell length, resulting in warpage,
  - Seamweld termination failures as the result of erratic and excessive loads introduced into the joints;

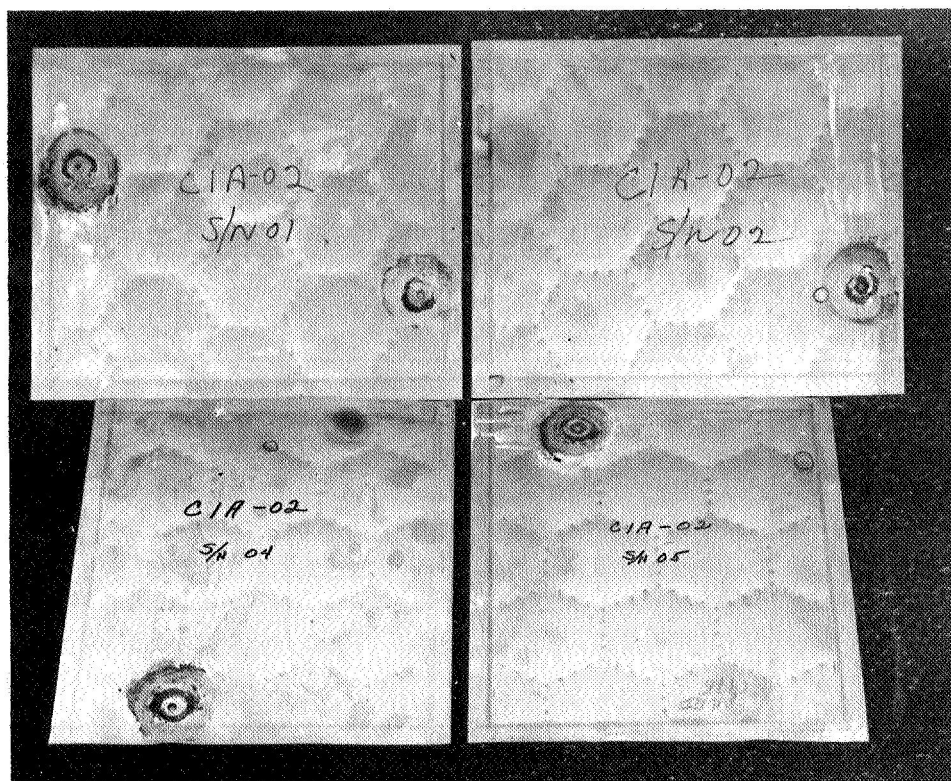
Figure 54.- Configuration C Test Specimen

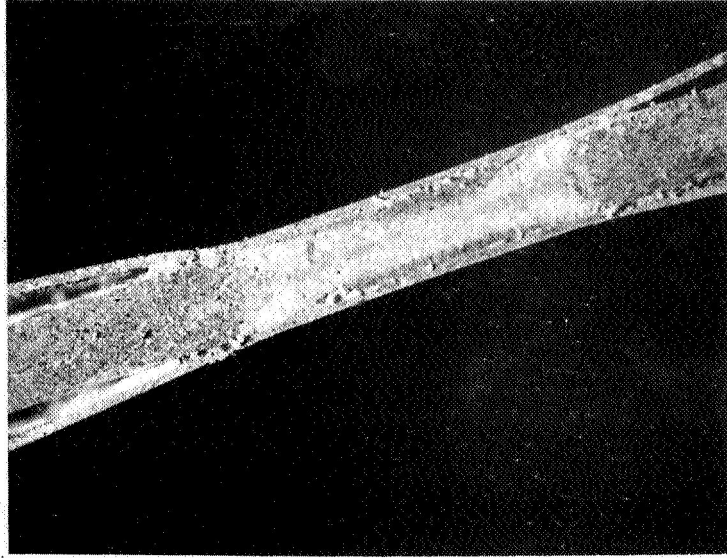
Figure 59.- Three-Play Weld showing "Dog-Bone" Appearance

Brazing development in the latter half of the first phase was limited to the "F" configuration as a possible backup to resistance welding development in that configuration. The results were mixed. Progress was made in reducing erosion of the stainless steel by using less braze alloy and by refining the time temperature cycle of the process. Specimens were made that had high strength joints which, when tested to failure, failed in the parent metal rather than in the braze. The specimens, however, were still highly oxidized in appearance and had inconsistent survival times in pressure cycling (fatigue) tests.

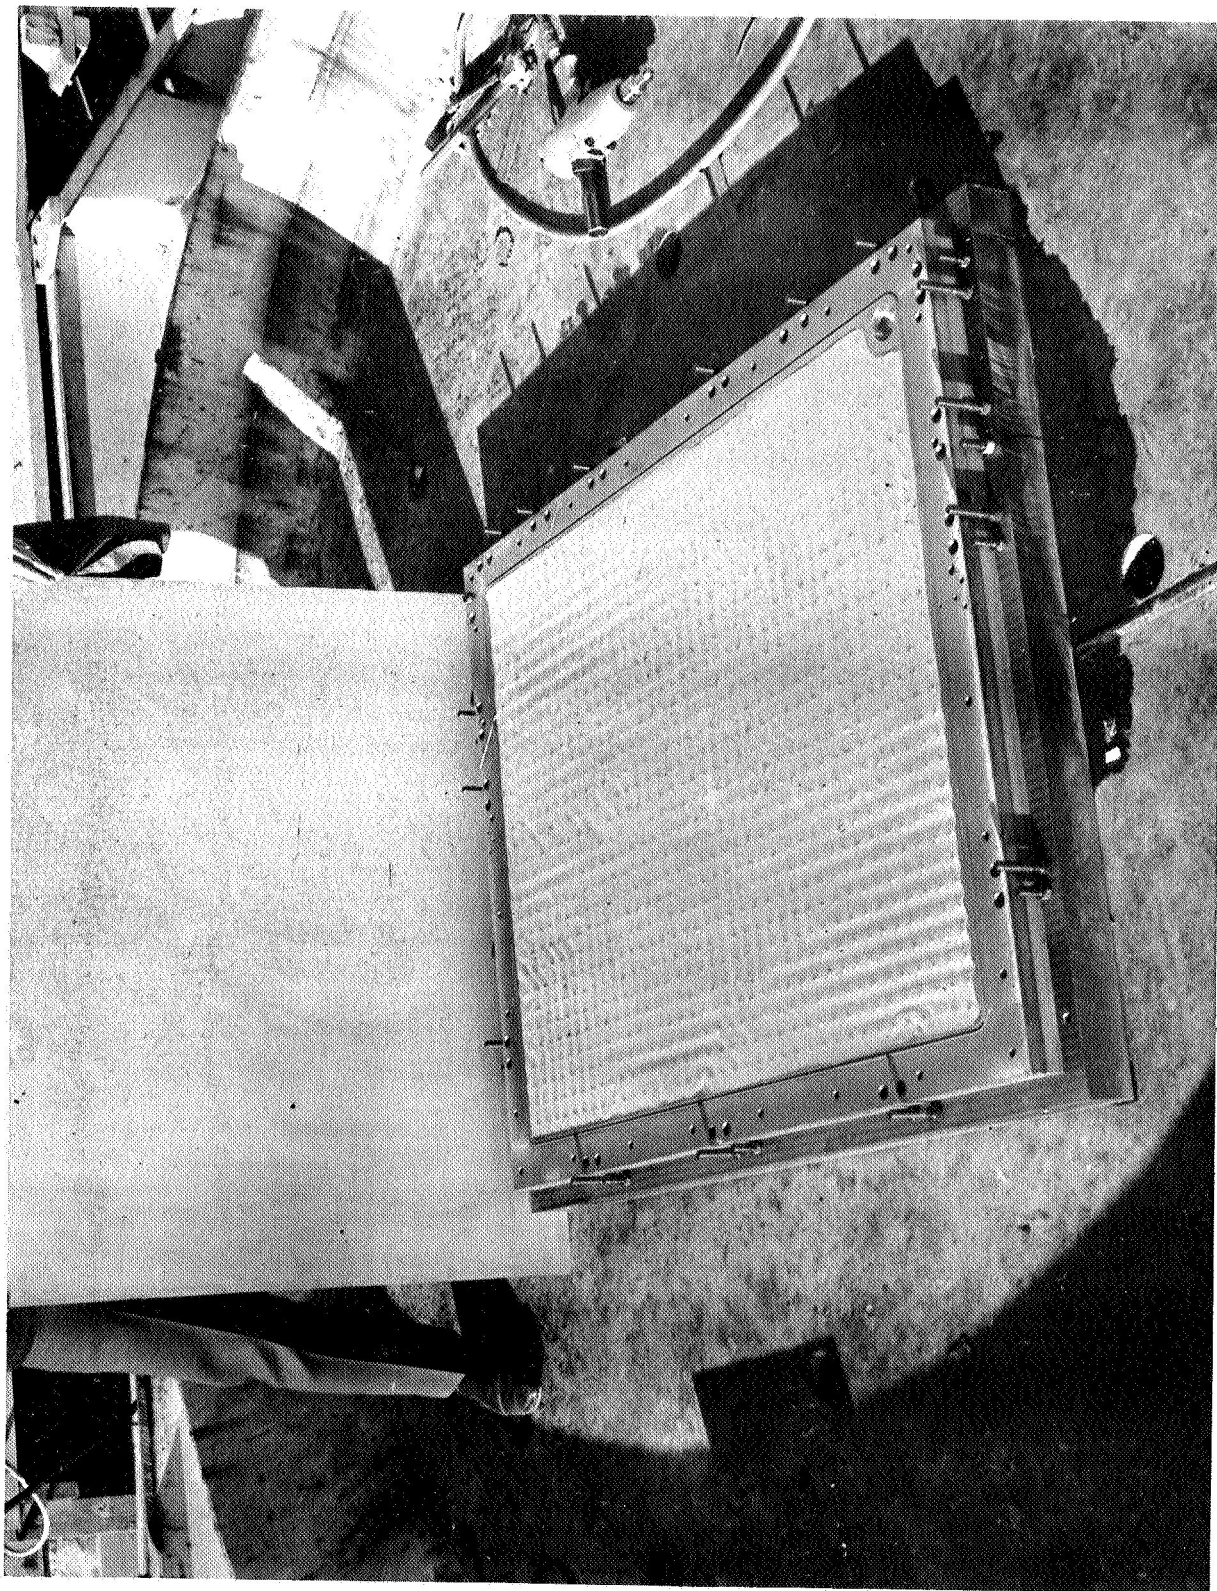
Figure 73.- Preformed Target Sheet Showing Plastic Separator

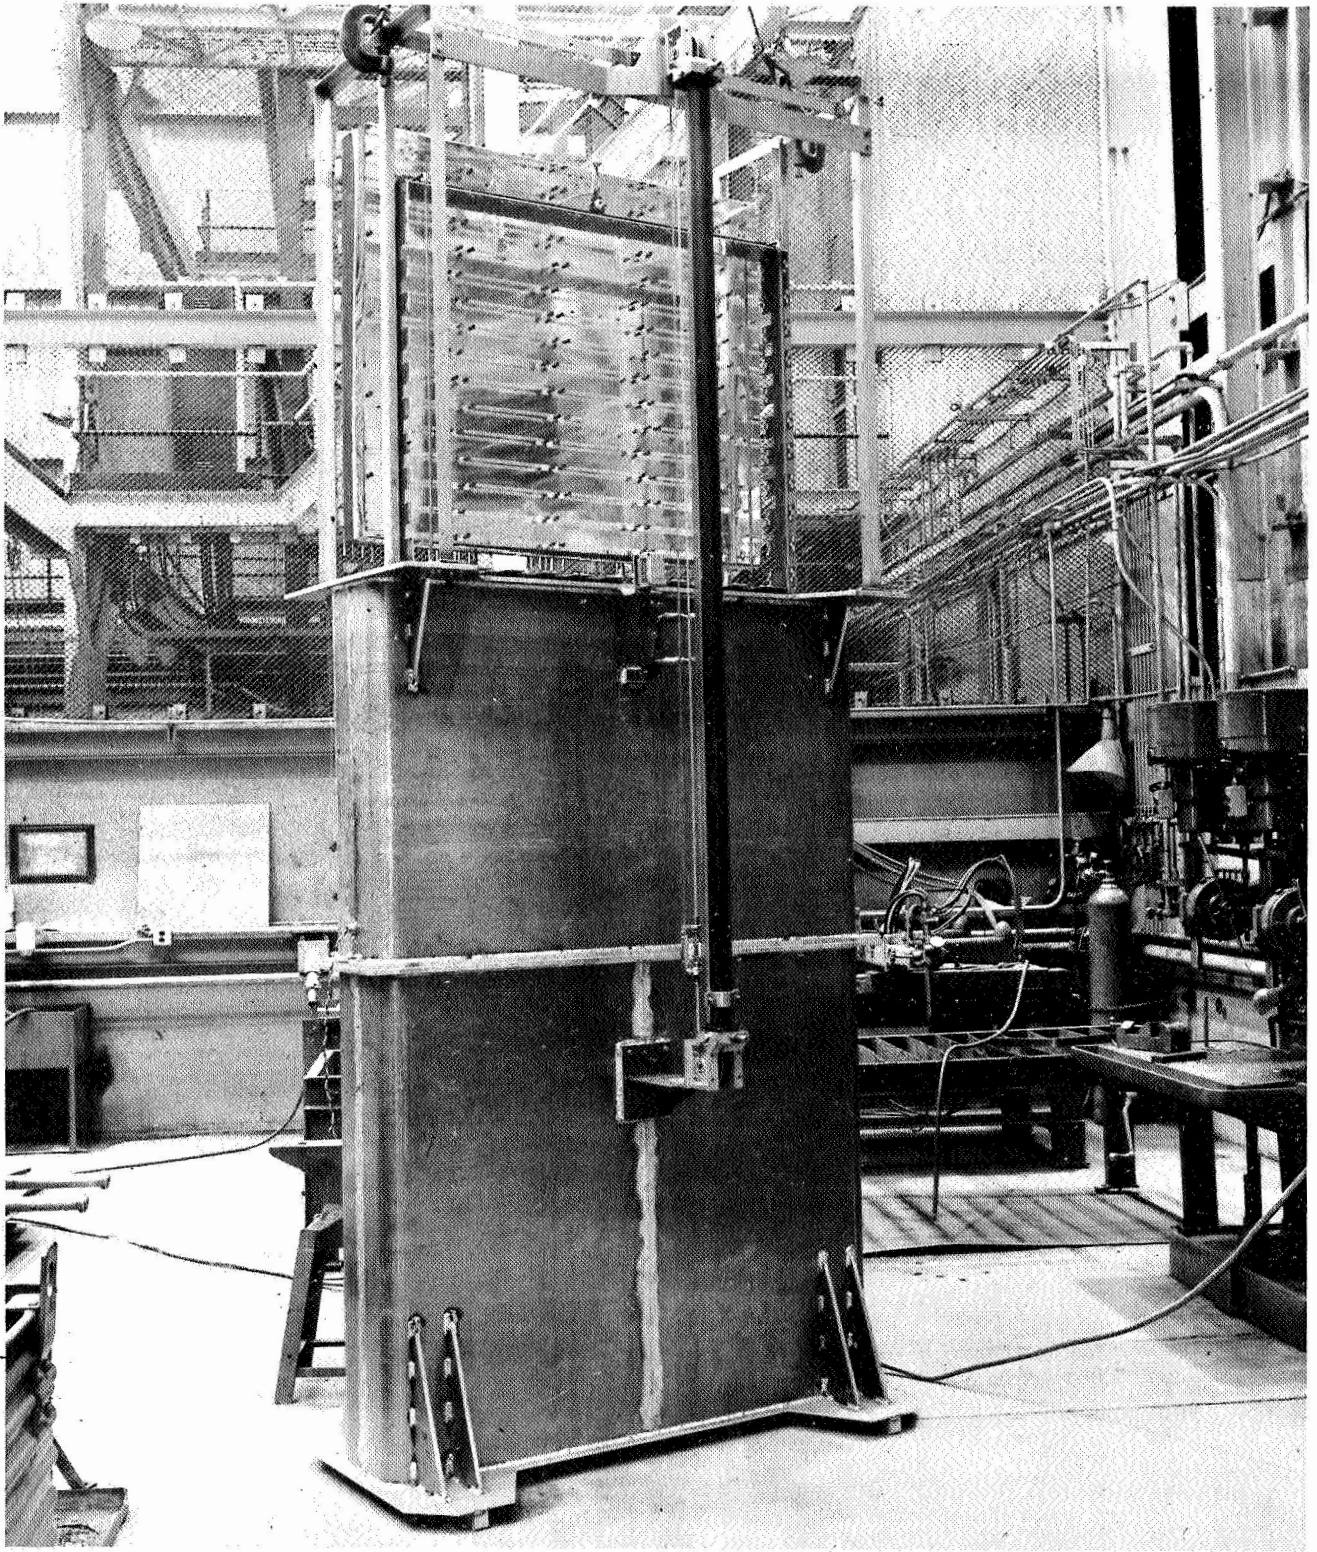
Figure 76.- Accelerated Life Cycle Fixture, First Module

During the last half of the first phase design of the full-size accelerated life cycle test fixture was completed. The first full-size module planned for use in a check out test in the vacuum chamber was fabricated during the Design Development Phase. This module is shown in figure 76. One of the quartz heating lamp banks is shown at the top of the picture with the detector holding frame in front. The cable mechanism for lowering the detector frame into the cold bath is also visible. Coils to carry liquid nitrogen are located in each of the tandem tank sections below the heating lamps. Metal templates for match drilling of the detectors and mounts were made during this phase. Figure 77 shows one of these templates. Special neoprene-coated screen separators were made to handle batches of target core and bumper sheet material
